CANEADEA DAM

ALLEGANY COUNTY, NEW YORK
INVENTORY NO. 484

PHASE I INSPECTION REPORT
NATIONAL DAM SAFETY PROGRAM

PHASE I INSPECTION REPORT
NATIONAL DAM SAFETY PROGRAM
CANEADEA DAM, INVENTORY NO. 464
CANEADEA CREEK, GENESEE RIVER BASIN
ALLEGANY COUNTY, NEW YORK

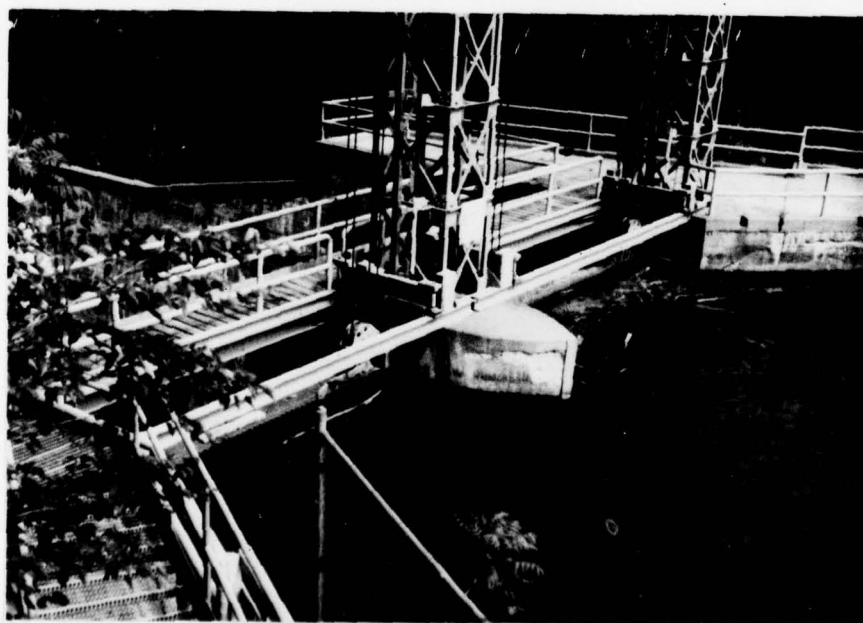
There is general spalling of the concrete surface immediately upstream of the gates.

AREA AT TOP OF SPILLWAY GATES

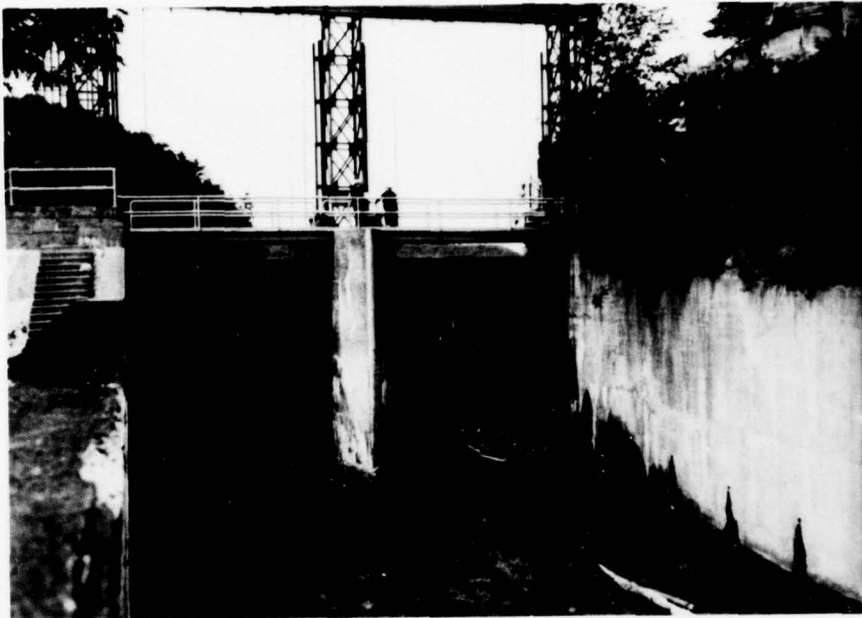
Both spillway gates were closed and the lake surface was about 0.4 ft below the top of gate (El 1440.0). Side seals were tight. At the north gate there was a slight leak at the bottom of the north end and moderate leakage squirting just above the bottom corner of the south end. At the south gate there was light leakage at both bottom corners. It was reported that the north gate bottom timber had been replaced in the spring of 1978 and was thought to be warped. Upstream side J-seals as shown on the drawings were not installed, but were stored in the gatehouse. The visible gate surfaces had patches of rust.

SPILLWAY GATES VIEWED FROM DOWNSTREAM

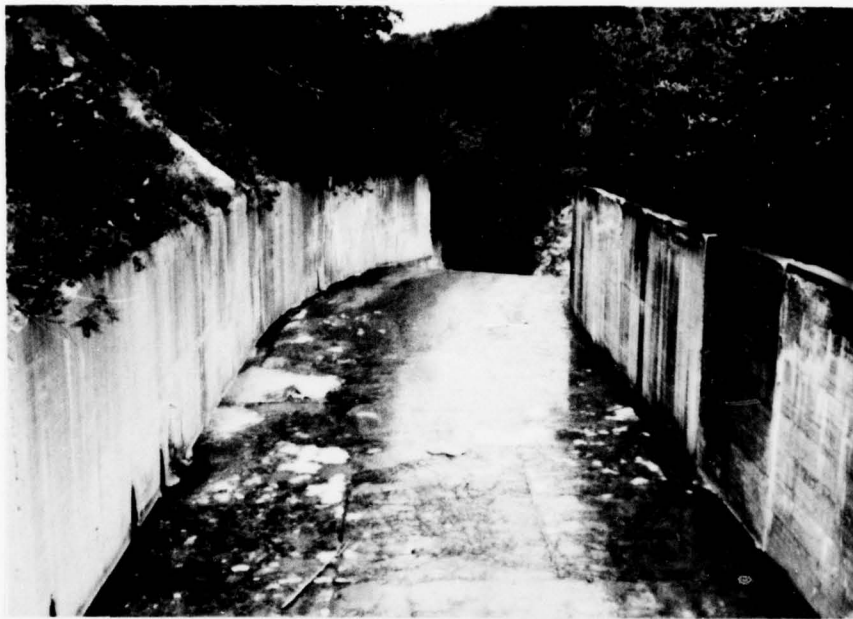
There is substantial erosion on the downstream portion of the sloping chute floor. The flatter floor slab near the abrupt end is also badly eroded. At the downstream end of the high right wall where the chute slab drops sharply there is some local undermining - a chunk of concrete several cubic feet in volume is missing.

SPILLWAY CHANNEL VIEWED FROM GATE BRIDGE

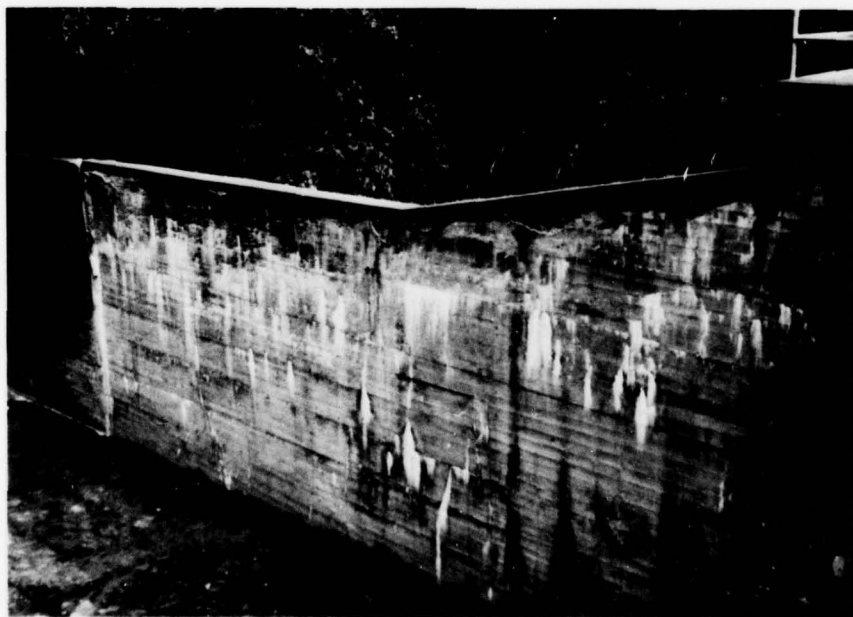
There are exposed rebars and several sizable spalled areas on the exterior face of the right spillway chute wall and carbonate deposits near the vent holes in the spillway chute wall. There is also deterioration of the concrete on both sides of several vertical monolith joints.

RIGHT WALL, SPILLWAY CHANNEL, FROM GATE BRIDGE

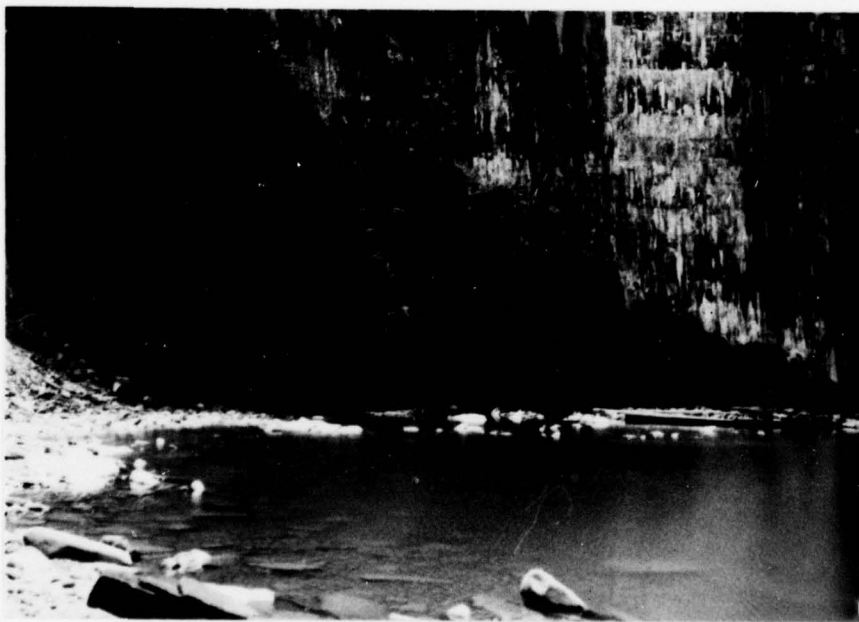
DOWNSTREAM FACE OF DAM, ROCK LEDGE AT BASE OF RIGHT
ABUTMENT

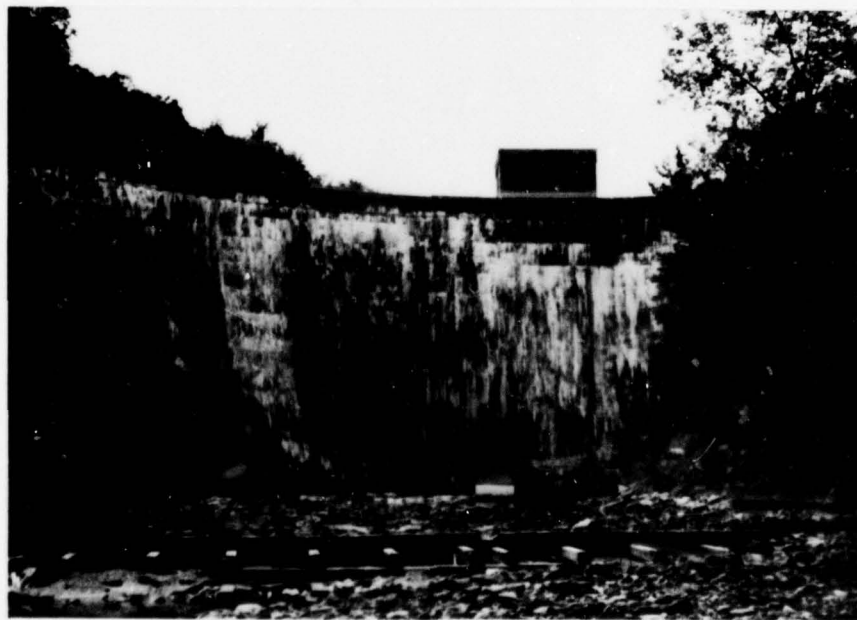
There are numerous areas with white deposits on the downstream face of the dam; deposition of as much as 2 inches thick has been observed. Minor leakage on downstream face of dam appears to be along horizontal and vertical joints of brickwork.

DOWNSTREAM FACE OF DAM FROM DOWNSTREAM WEIR IN
STREAM BED
